Re: Clean Water Act Pretreatment Inspection

Enclosed is the report for our August 15, 2018 Pretreatment inspection of the Pacific Seafood facility at the above address in Eureka, CA.

**Region 9 Enforcement Division**  
**75 Hawthorne Street**  
**San Francisco, CA 94105**  
**INSPECTION REPORT**

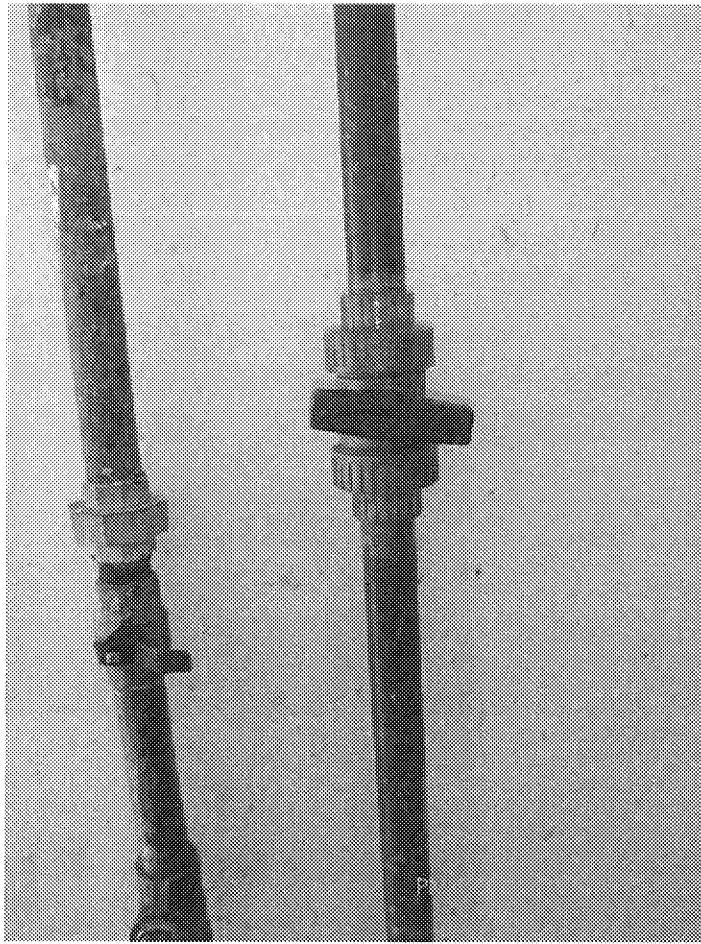
1. The pipe from the ozone generating system (a sanitizer for fish processing) was leaking under the facility's dock (Photograph 5). According to the facility representative, the valve on the pipe (Photograph 36) is located behind the deicing machine and employees may bump the valve as they move past it, which may unlock it and allow this water to discharge. The inspection team recommended that the facility representative put a lock on the valve to prevent the opening of the pipe. Following the inspection, the facility representative emailed a photo of the location of the pipe, showing that the pipe had been removed.

**Photograph 36.** View of the valve to the ozone generating system after the facility representative closed the valve.
